**WASTEWATER
CLARIFIER
IMMERSION PROTECTION**

CLARIFIER
REFURBISHMENT
OCTOBER, 2011

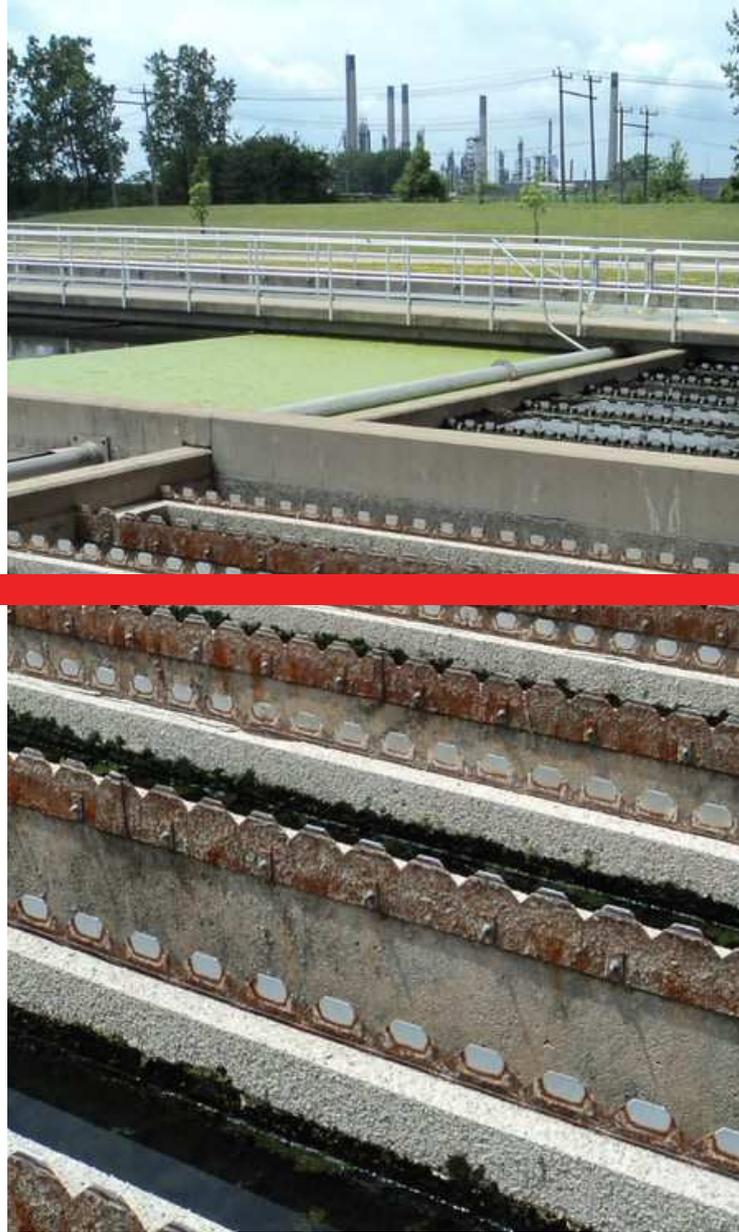
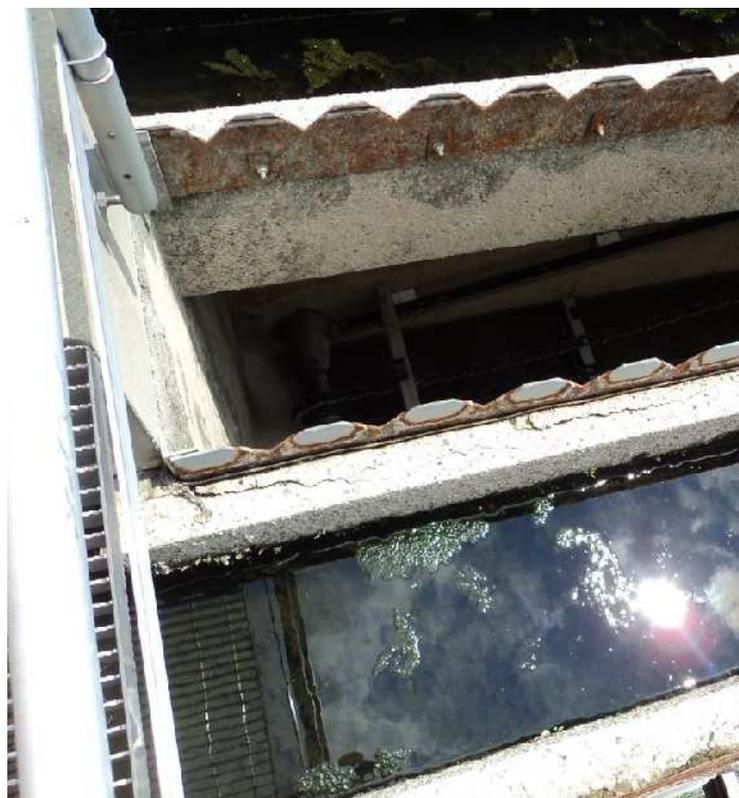
The only wastewater treatment plant in the city of Sarnia serves over 70,000 citizens in Ontario. The secondary clarifiers at the Water Pollution Control Center were pitted and deteriorated due to chemical attack from the biological treatment process. The city decided to coat one of the four secondary tanks to see if the results were favorable.

The fact that the secondary clarifiers (young, compared to the 50-year-old primary clarifiers) needed repair so badly meant that the plant needed to make some moves quickly.

The tank was power washed with 10,000 psi and allowed to dry. Once the concrete was dry, pits, cracks or holes were conditioned with Belzona 4911 and then filled with Belzona 4131 using a trowel.
